Date: May 10, 2013

Test Report For:

**ANSI/BIFMA X5.1-2011
CHAIR TEST STANDARD**

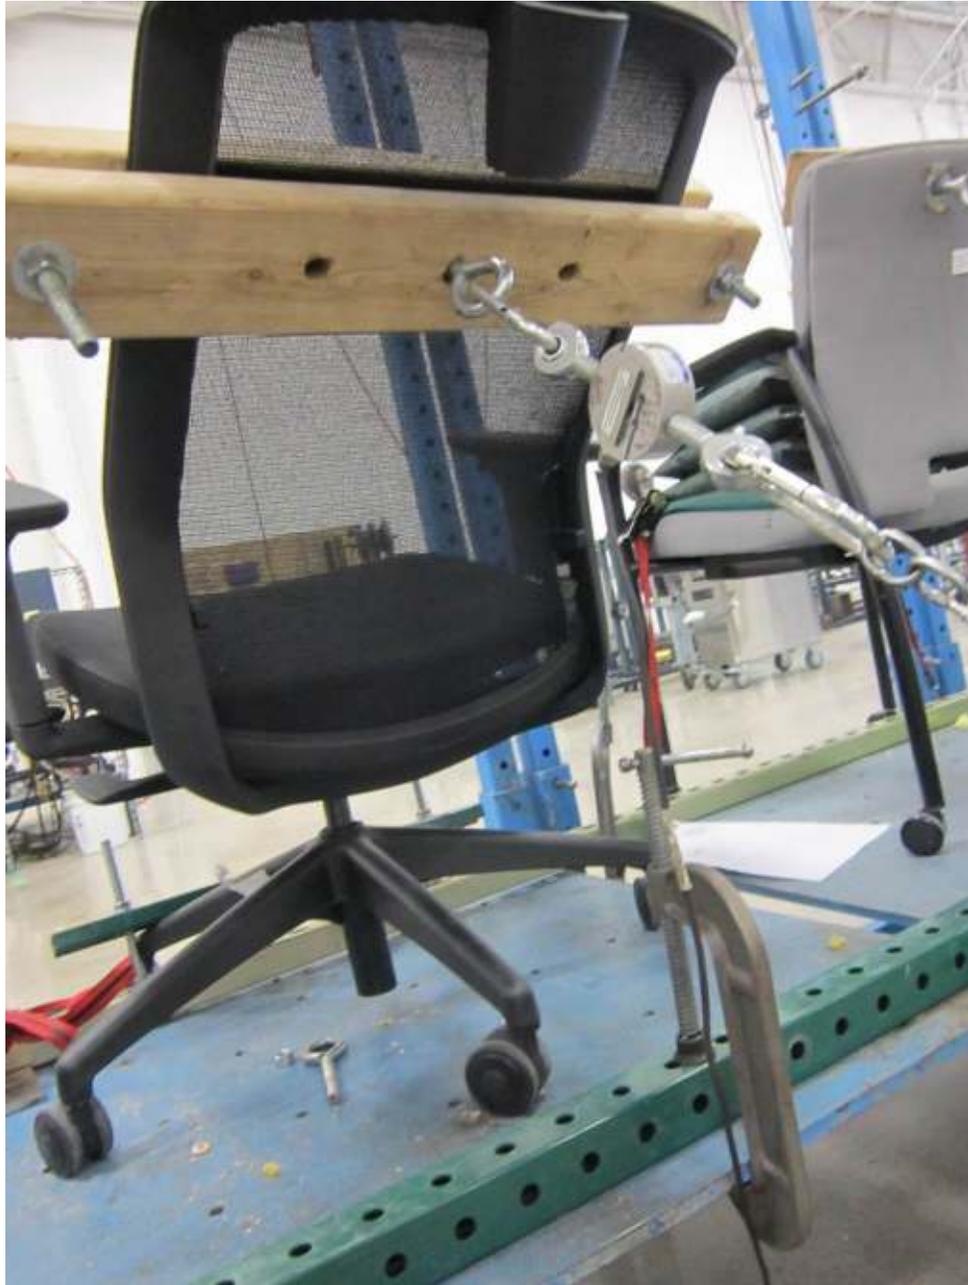
Back Strength Test

Test Method: ANSI/BIFMA X5.1 2011; Test No. 5
 Functional Load: 200 lbf.
 Proof Load: 300 lbf.
 Number of Samples Tested: One (1)

Sample ID	Static Load	Description of Results
3	200	Pass
	300	Pass

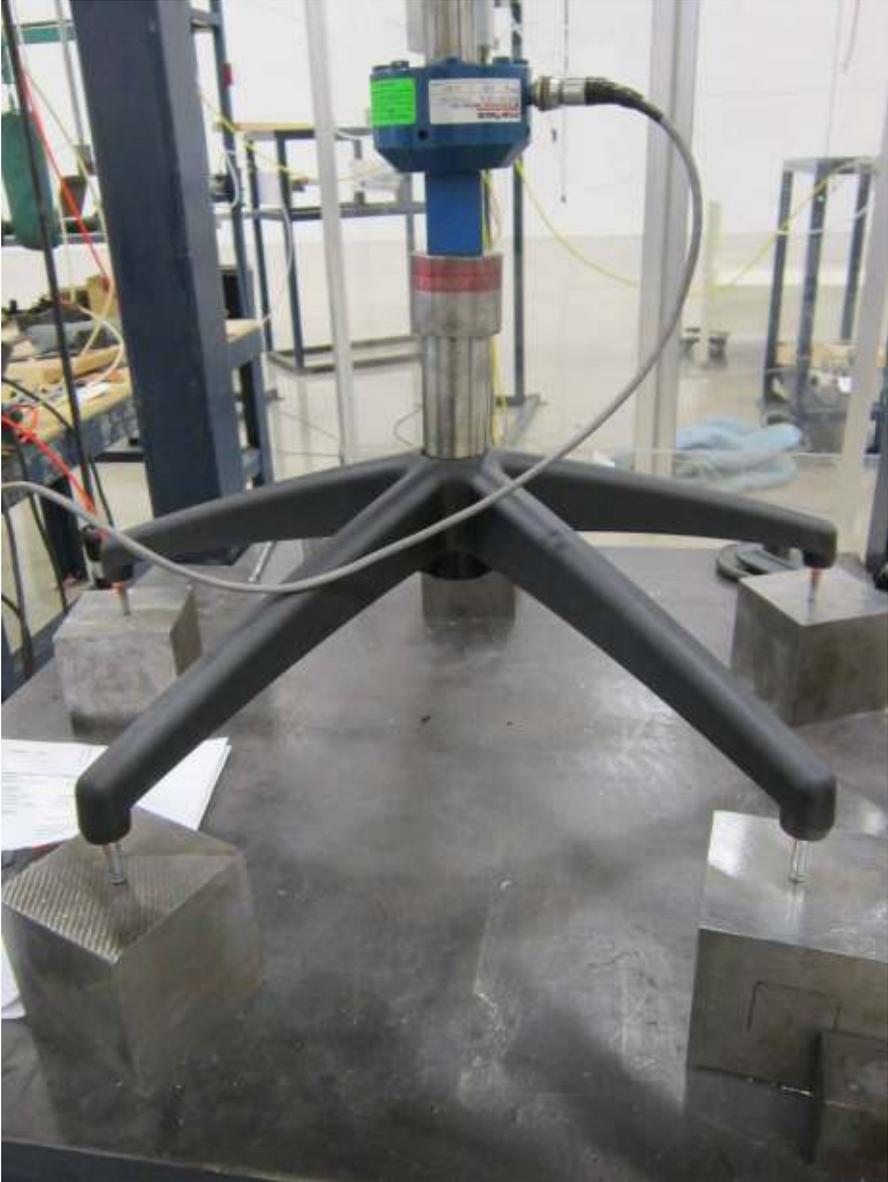
Base Test – Static

Test Method: ANSI/BIFMA X5.1-2011; Test No. 7
Time Duration of Test: 1 Minute
Functional Static Load: 2500 lbf.
Proof Static Load: 2500 lbf.
Number of Samples Tested: One (1)

The submitted sample meets the acceptance criteria of the test described above. Refer to the following page for photograph.

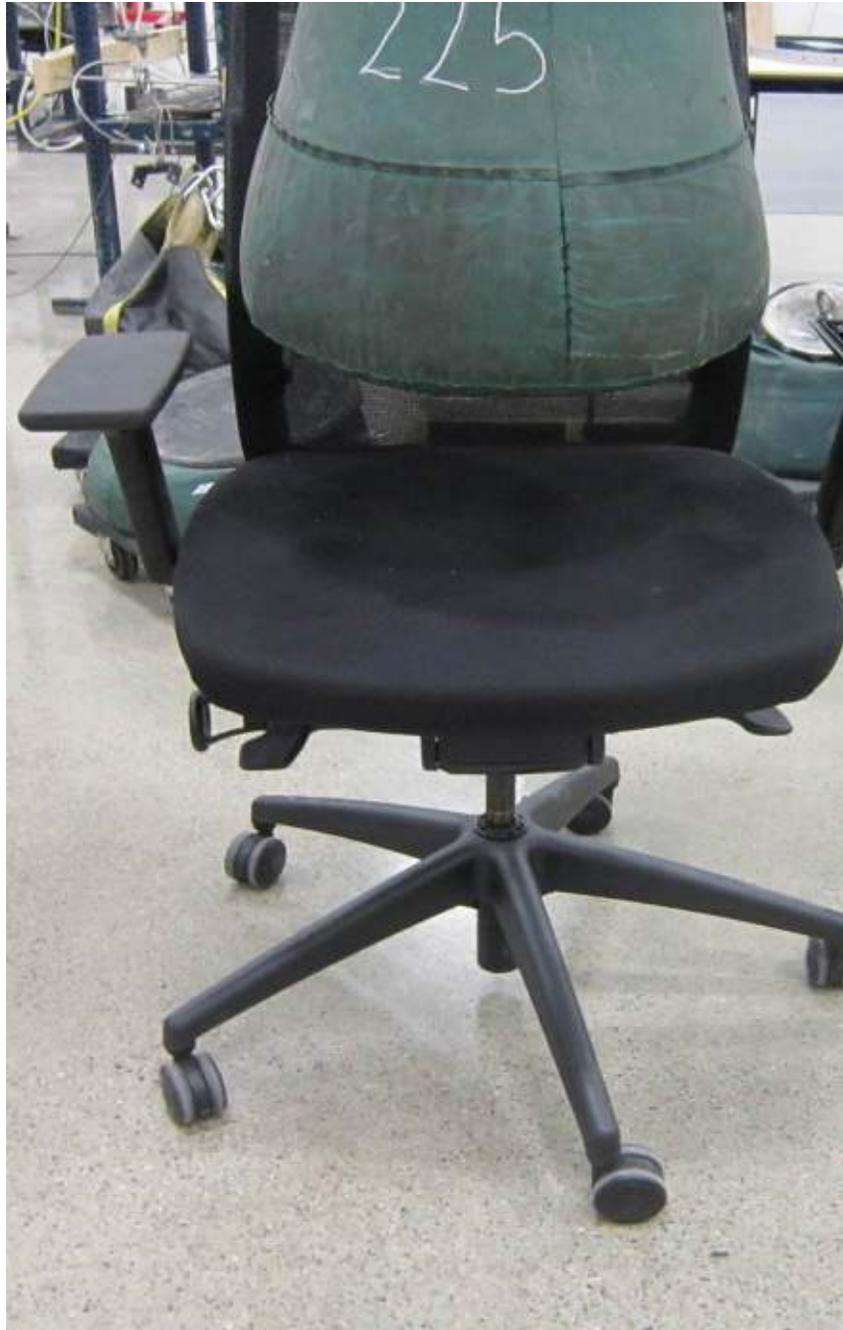
DROP TEST – DYNAMIC

Test Method: ANSI/BIFMA X5.1-2011; Test No. 8
 Functional Load: 225 lbs.
 Proof Load: 300 lbs.
 Drop Height: 6"
 Number of Samples Tested: One (1)

Sample Number	Highest Position	Results
3	Functional Load - 225 lbs	Pass
	Proof Load - 300 lbs	Pass

Sample Number	Lowest Position	Results
3	Functional Load - 225 lbs	Pass
	Proof Load - 300 lbs	Pass

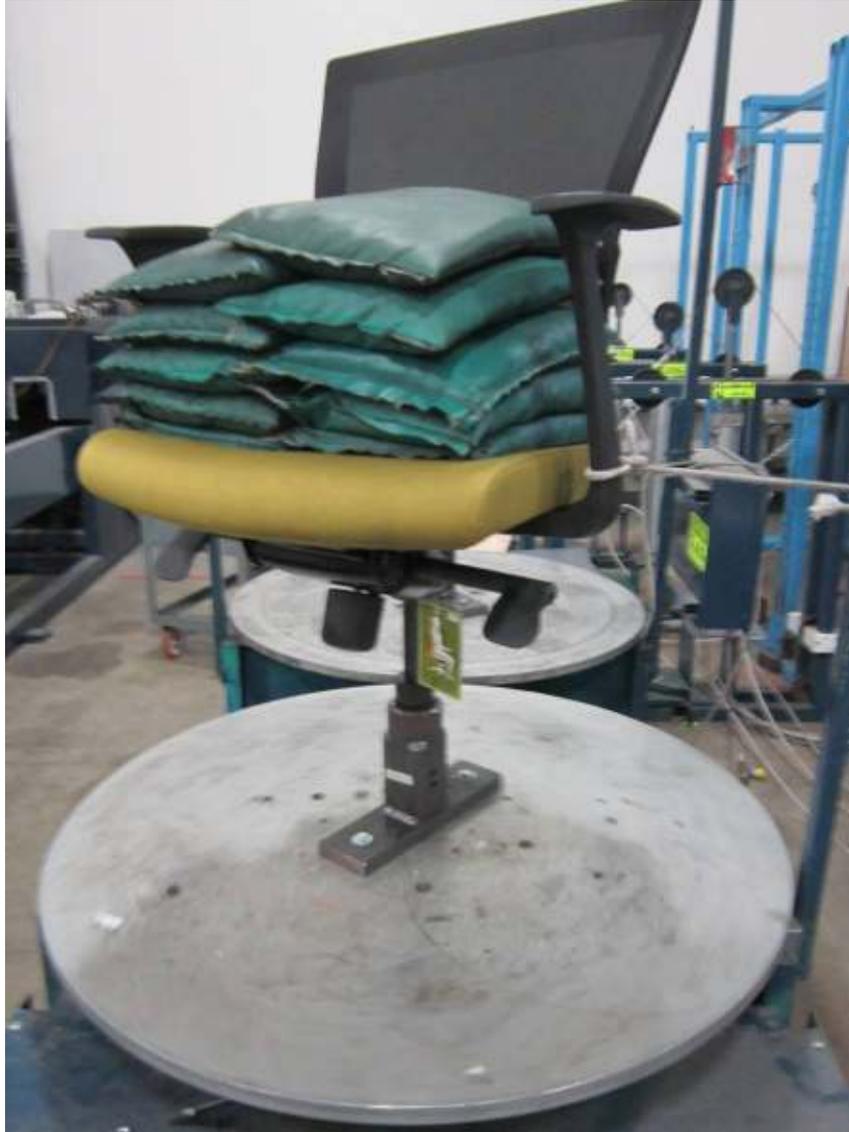
Swivel Test – Cyclic

Highest Seat Position: 60,000
 Lowest Seat Position: 60,000
 Rotation: 360°
 Cycles per Minute: 5-15
 Load in Seat: 250 lbs.
 Number of Samples Tested: One (1)

Sample ID	Seat Position	Number of Cycles	Description of Results
1	Highest Setting	60,000	Pass
	Lowest Setting	60,000	Pass

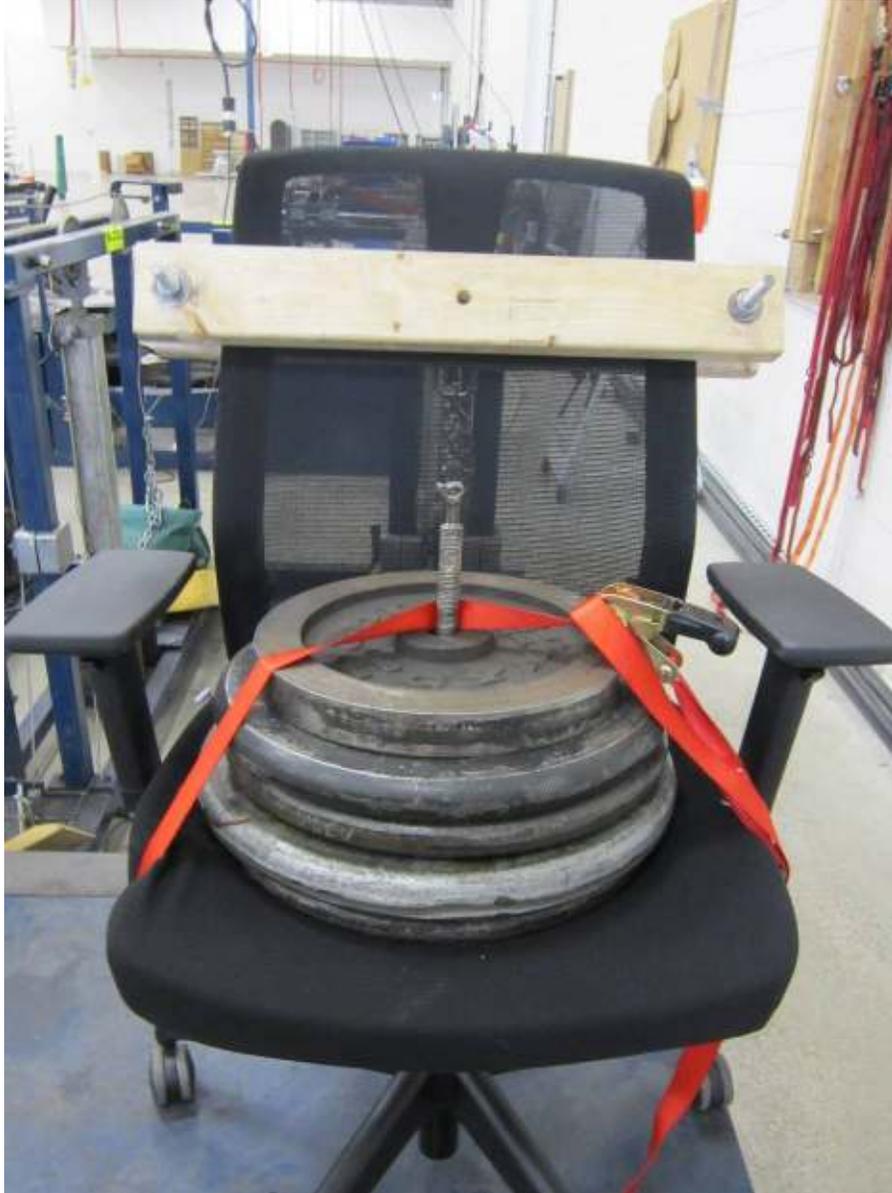
Tilt Mechanism Test-Cyclic

Tilt Adjustments: Set all adjustments at normal use conditions.

Number of Cycles: 300,000

Load in Seat: 225 lbs.

Sample ID	Number of Cycles	Description of Results
1	300,000	Pass

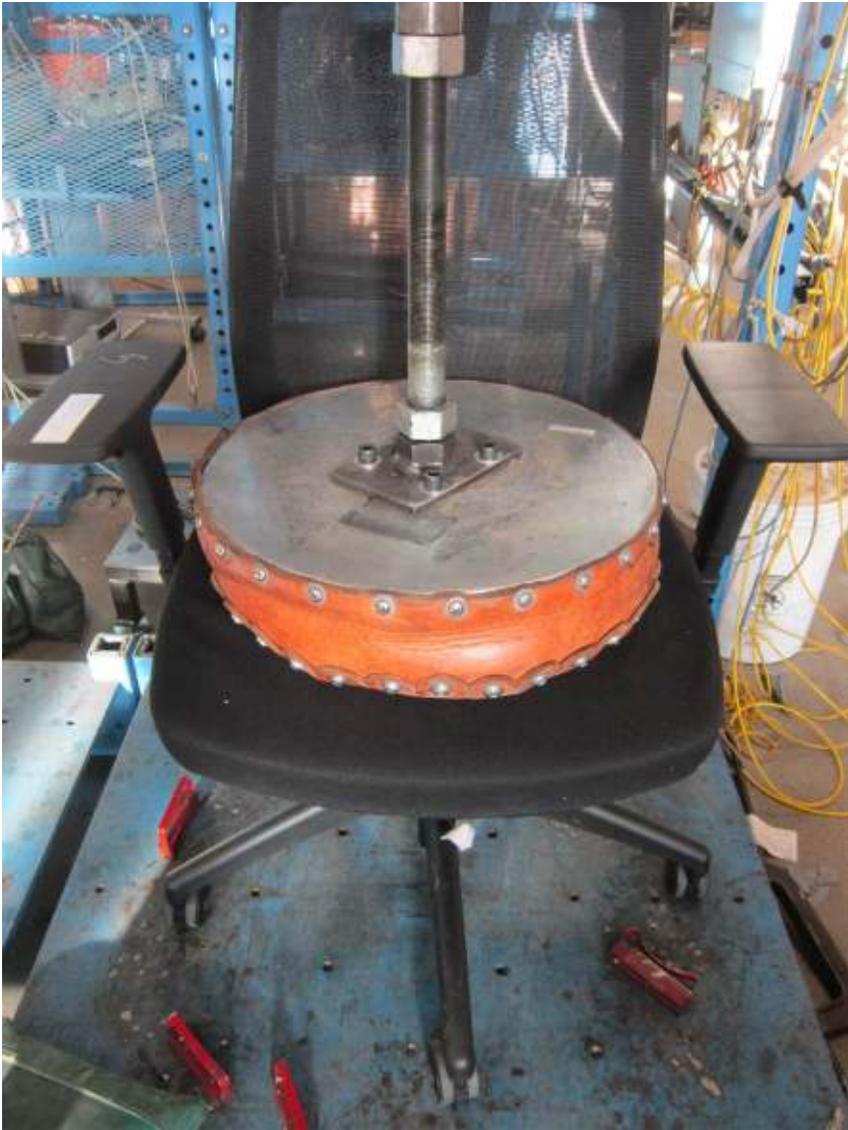
Seating Impact Test

Bag Diameter: 16"
 Bag Weight: 125 lbs.
 Number Cycles: 100,000
 Height of Drop: 1.2"
 Cycles per Minute: 10 to 30

Sample No.	Number of Cycles	Description of Results
3	100,000	Pass

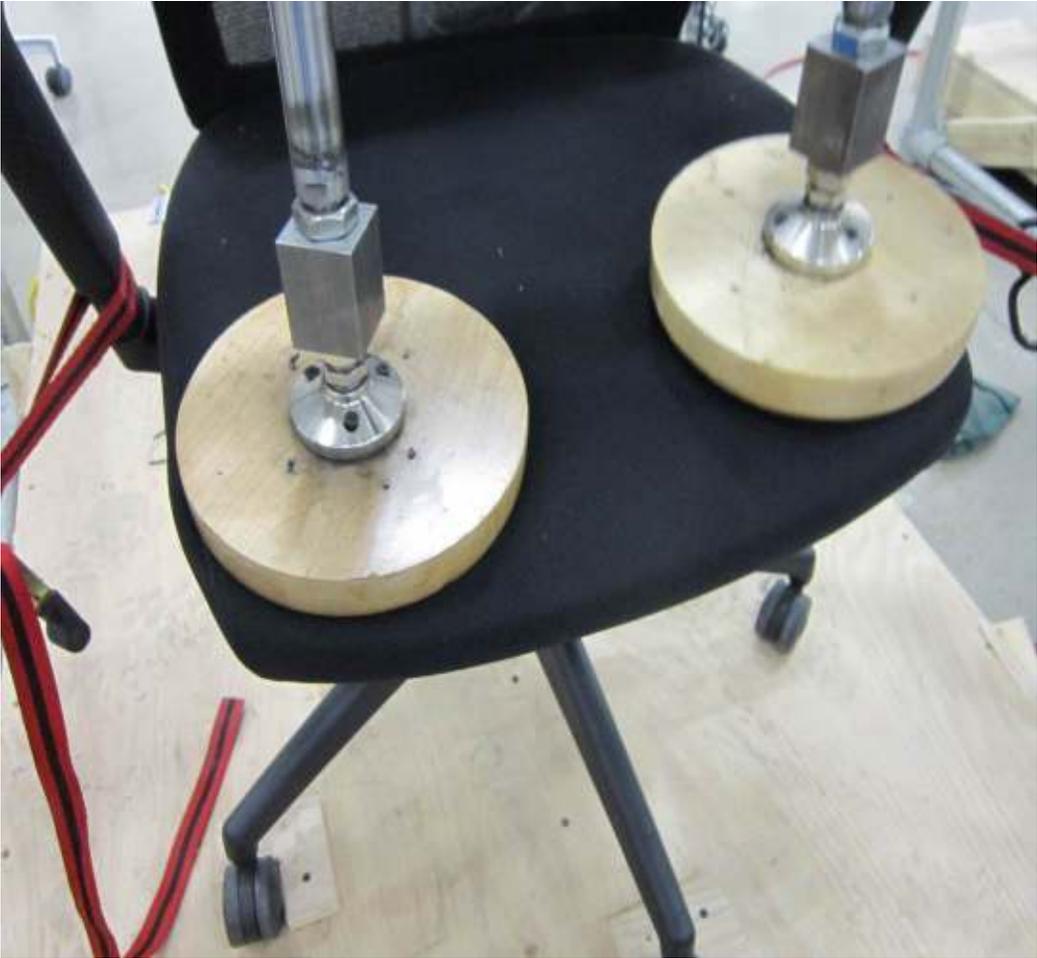
Front Load Ease

Bag Diameter: 8"
 Bag Weight: 165 lbs.
 Number of Cycles Required: 20,000 to each Front Corner
 Cycles per Minute: 10 to 30
 Number of Samples Tested: One (1)

Location of Force	Number of Cycles	Description of Results
Left Front Corner	20,000	Pass
Right Front Corner	20,000	Pass

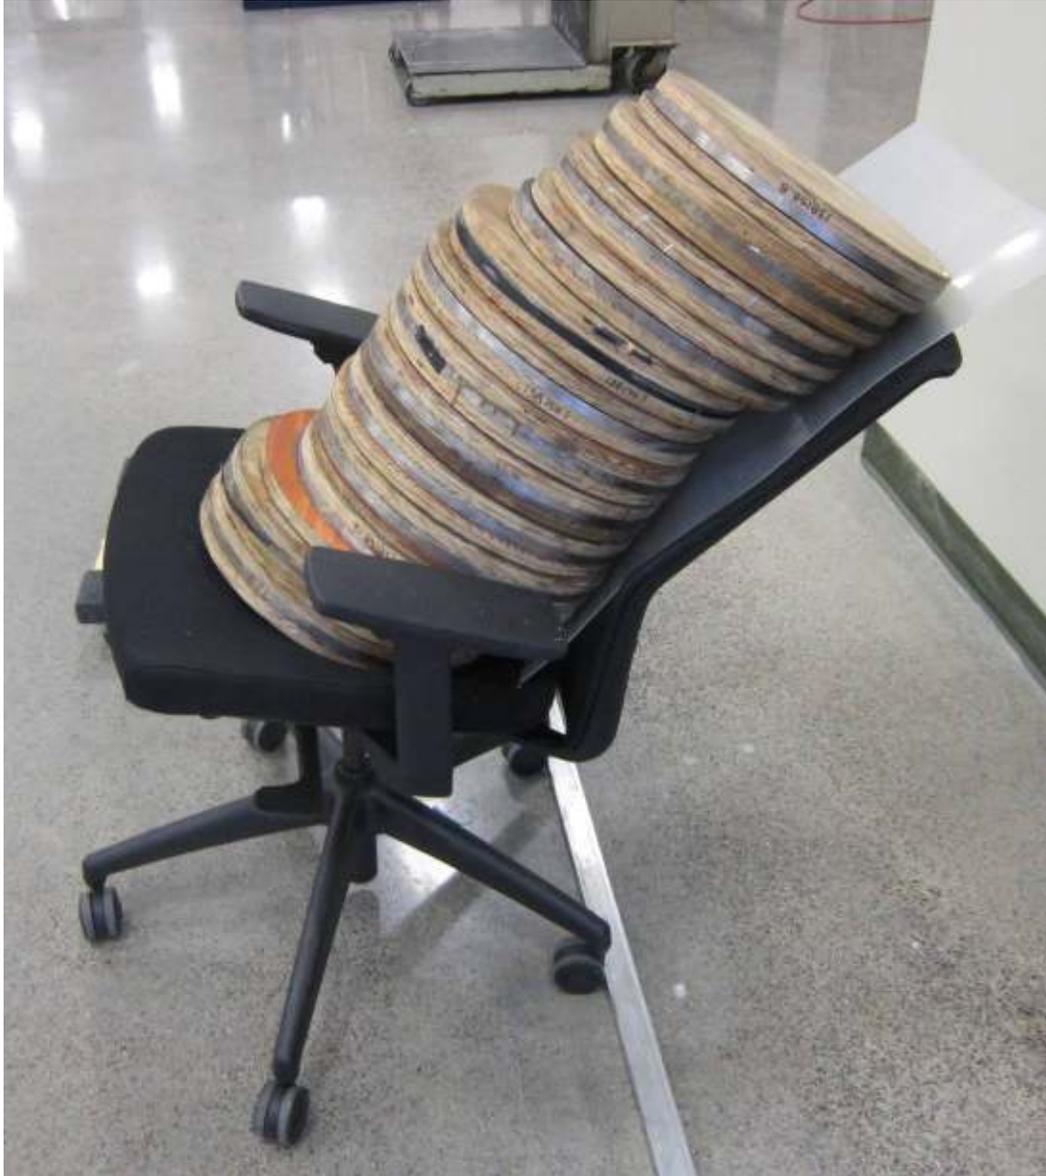
Stability Test - Rear

(Rear Stability Only): Type I: 286 lbs. (13 disks)
Type II: 286 lbs (13 disks)
Type III: 132 lbs (6 disks)

The force to tip shall not be less than:
Type I: Chair must not tip over
Type II: Chair must not tip over
Type III: [F = 1.1 (47 – H) pounds force.]. H is the seat height in inches. For chairs with seat height equal to or greater than 710 mm (28.0 in.), a fixed force of 93 N (20.9 lbf.) shall be applied.

Sample ID	Front Stability	Rear Stability	Results
2	21.5 lbf. to tip	Pass	Pass

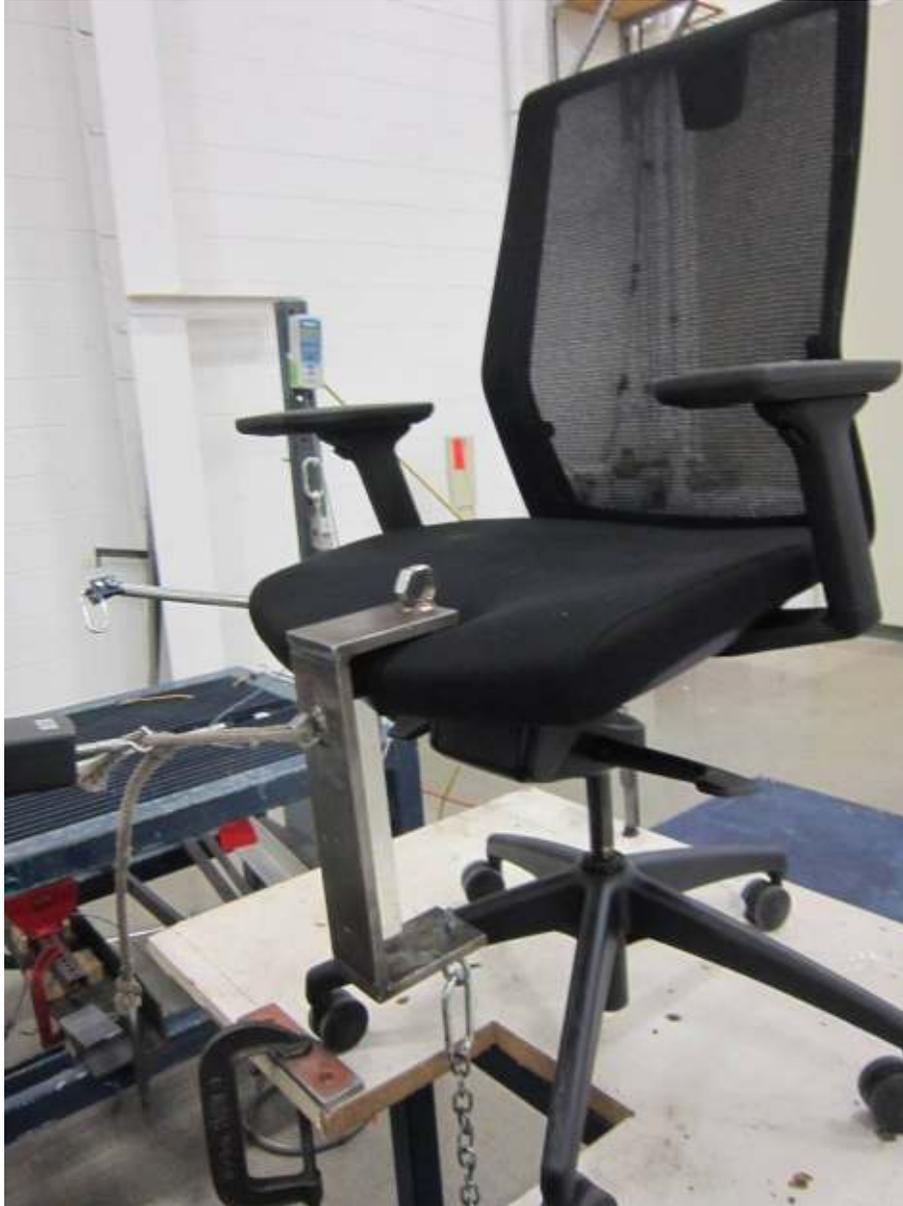
Stability Test - Front

Alternative: N/A
Vertical Load: 135 Lbs
Horizontal Force: 4.5 Lbs
Number of Samples Tested: One (1)

Front Stability: The chair shall not tip over as the result of the force application of 4.5 lbf..

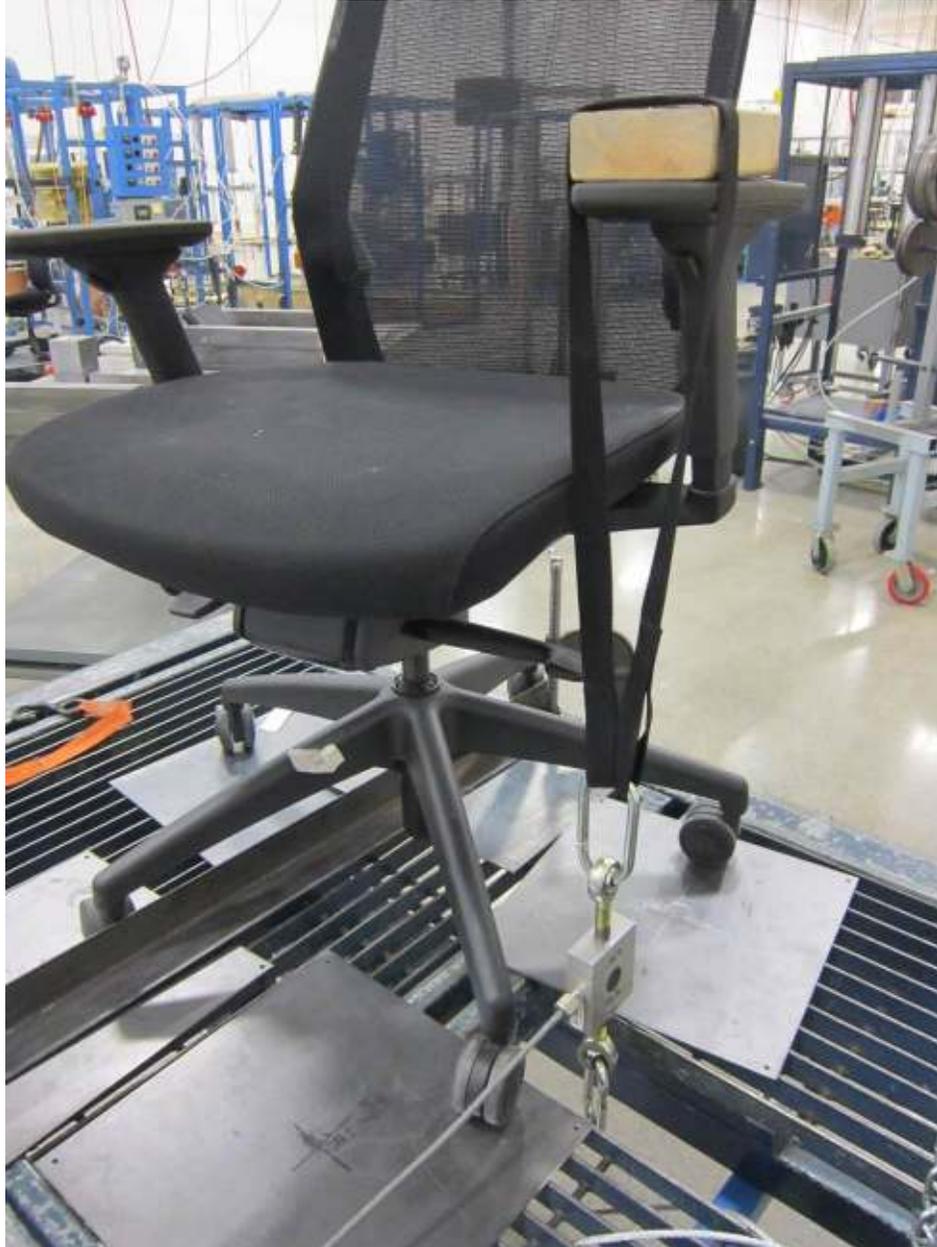
Arm Strength Test Vertical-Static

Test Method: ANSI/BIFMA X5.1-2011; Test No. 13
 Functional Static Load: 169 lbf.
 Proof Static Load: 253 lbf.
 Number of Samples Tested: One (1)

Sample ID.	Static down Load (lbf.)	Description of Results
1	169	Pass
	253	Pass

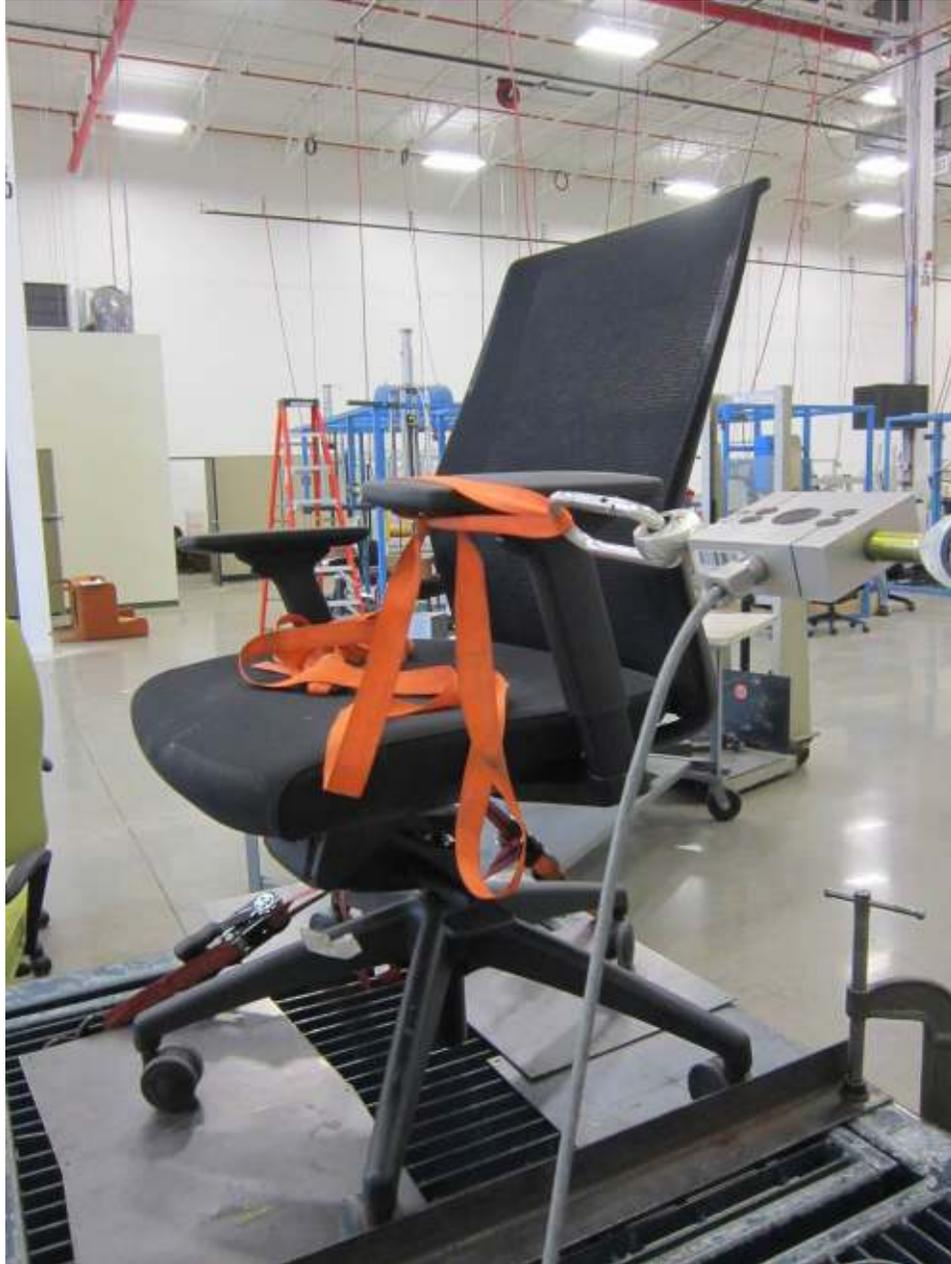
Arm Strength Test- Horizontal-Static

Test Method: ANSI/BIFMA X5.1-2011; Test No. 14
 Functional Force: 100 lbf.
 Proof Load: 150 lbf.
 Number of Samples Tested: One (1)

Chair	Load (lbs)		Results
4	Functional Load	100	Pass
	Proof Load	150	Pass

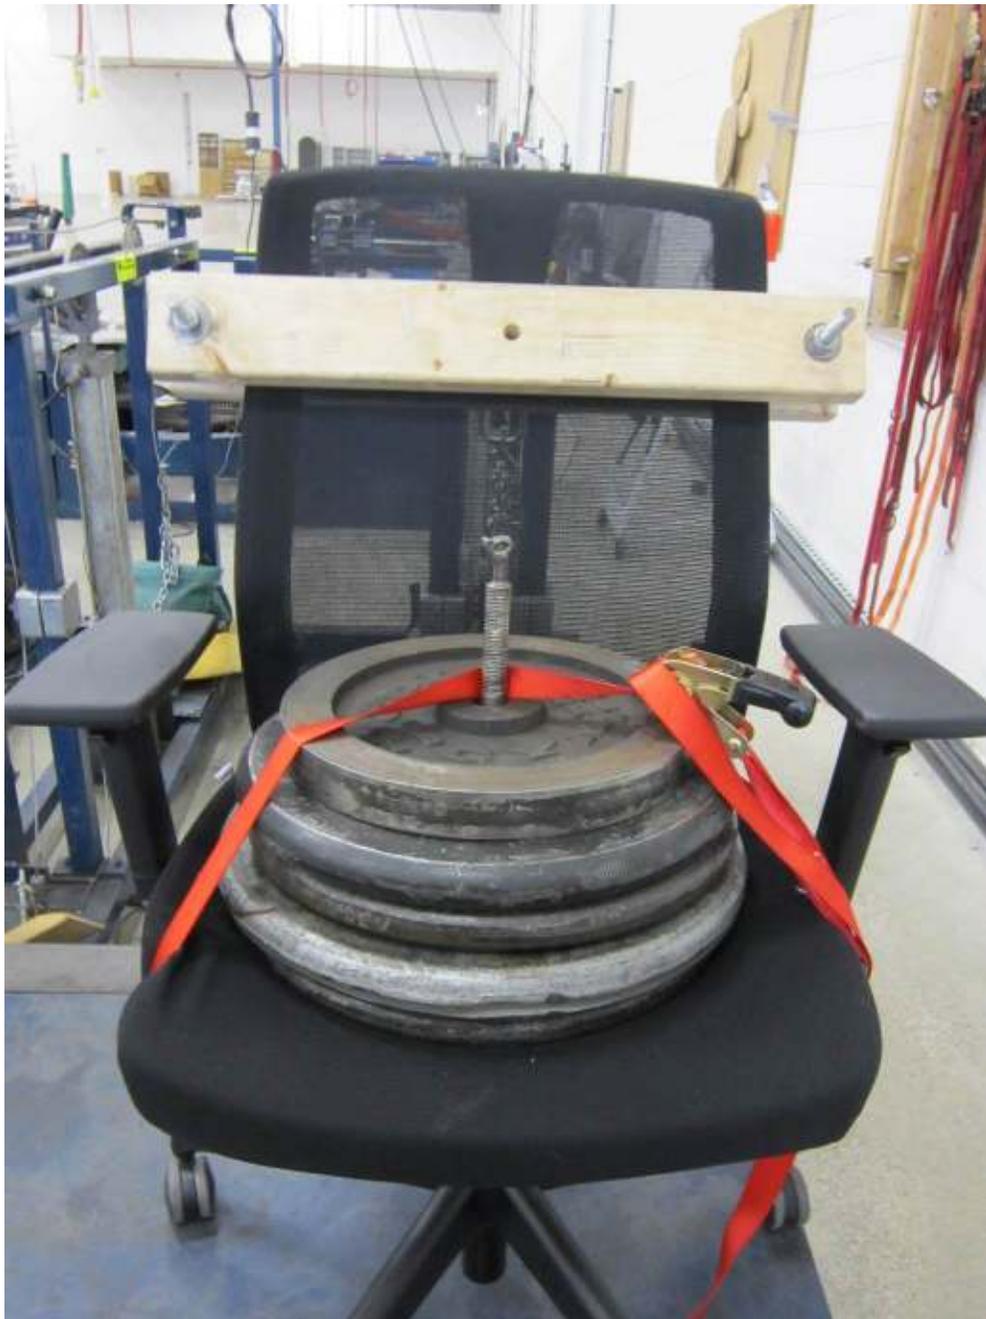
Back Durability Test-Cyclic

Test Method: ANSI/BIFMA X5.1-2011; Test No. 15
 Backrest Width: 17-1/2"
 Number of Cycles Required: 120,000
 Center Pull Location: 80,000
 Off Center Pull Location: 40,000
 Force Applied to Chair Back: 100 lbf.
 Load in Seat: 225 lbs.
 Cycles per Minute: 10 to 30
 Number of Samples Tested: One (1)

Sample ID	Pull Location	Number of Cycles	Description of Results
3	Center Pull	80,000	Pass
	Off Center Pull	40,000	Pass

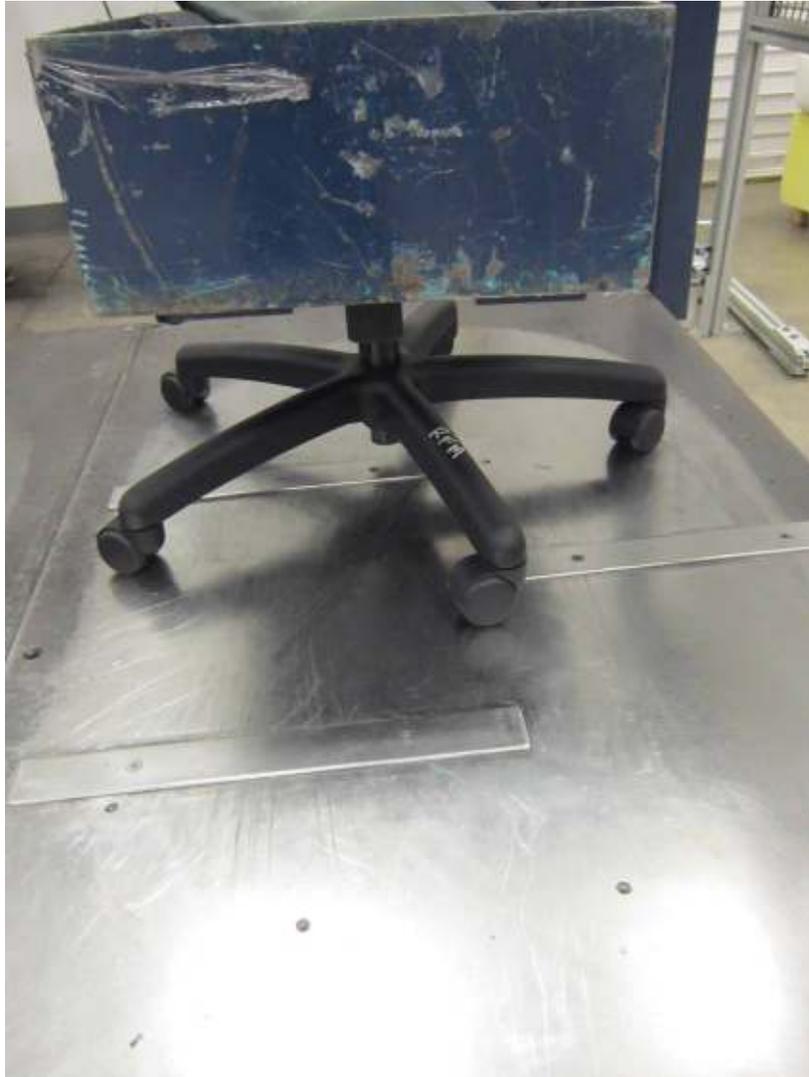
Caster/Chair Base Durability Test - Cyclic

Test Method: ANSI/BIFMA X5.1-2011; Test No. 17
 Number of Casters on Base: 5
 Type of Casters (Hard or Soft): Hard
 Travel Distance (Inches): 30 Inches
 Number of Cycles Required: 100,000
 Cycles over Obstacles: 2,000
 Cycles over Smooth Plate: 98,000
 Cycles per Minute: 9
 Weight in Seat: 250 lbs.
 Number of Samples Tested: One (1)

Sample ID	Test Condition	Number of Cycles	Description of Results
1	Over Obstacles	2,000	Pass
	Over Smooth Plate	98,000	Pass

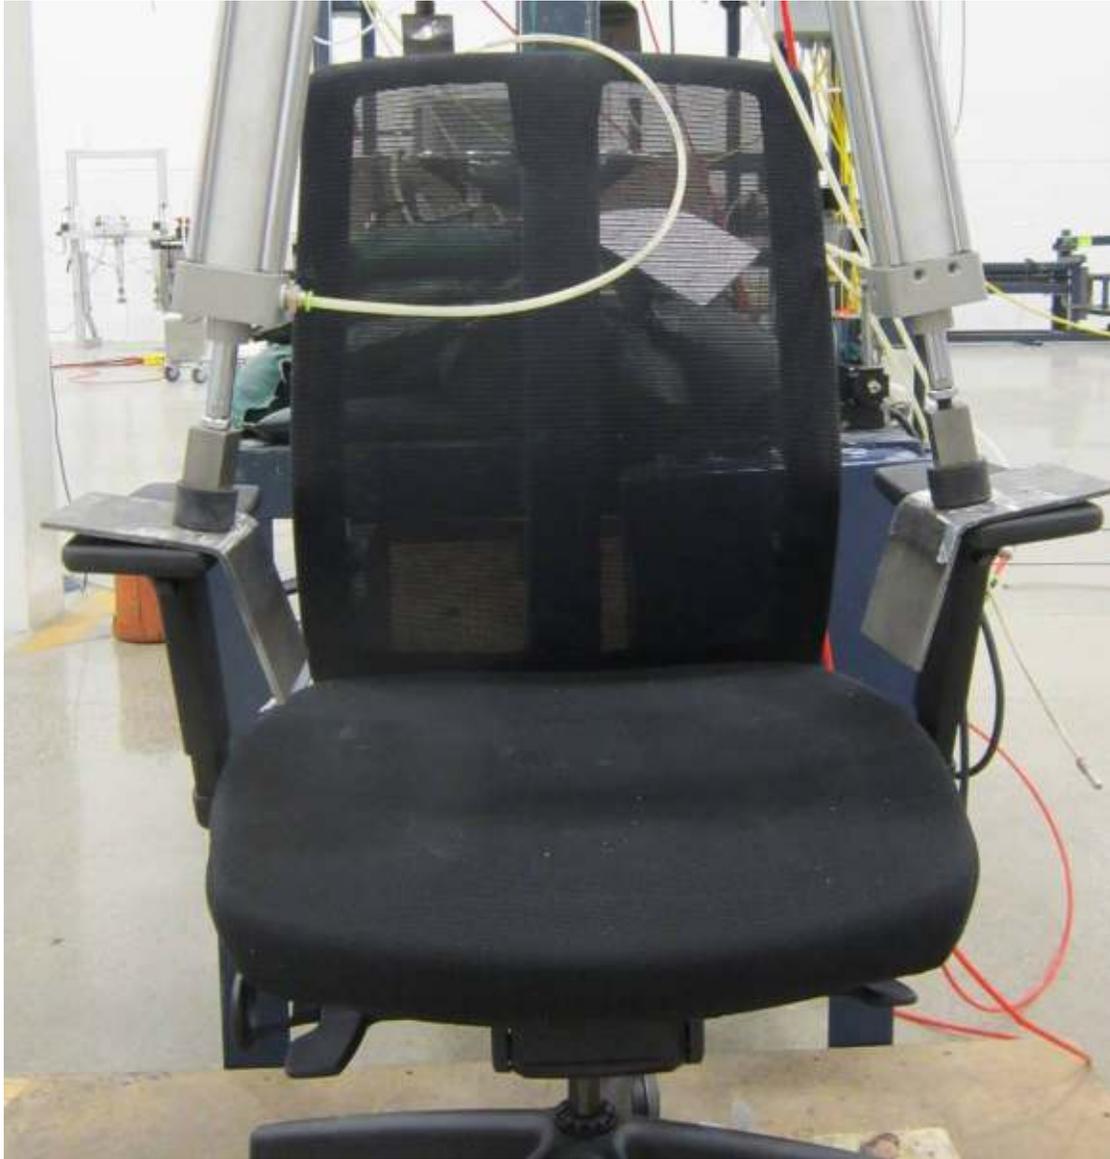
Arm Durability Test – Cyclic

Test Method: ANSI/BIFMA X5.1-2011; Test No. 21
Load To Each Arm: 90 lbs.
Angle of Force: 10 Degrees from Vertical
Number of Cycles Required: 60,000
Cycles per Minute: 10 to 30
Number of Samples Tested: One (1)

Sample ID	Number of Cycles	Description
1	60,000	Pass
